Catapult SME engagement

# Lofrix cutting trials

# Introduction

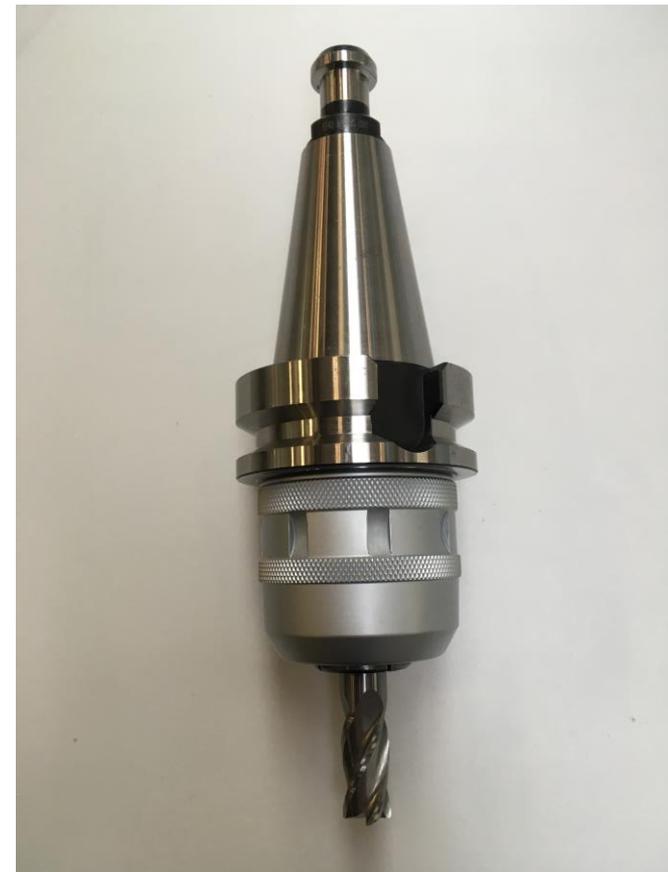
2off Nikken-  
NBT40-C20-70  
tool holders  
with (OSG)  
cutter
